STRUCTURAL APPRAISAL FOR FIRE
DAMAGED BUILDINGS

BY
Dr. Rizgar Salih Amin
(BSc,MSc,PhD)

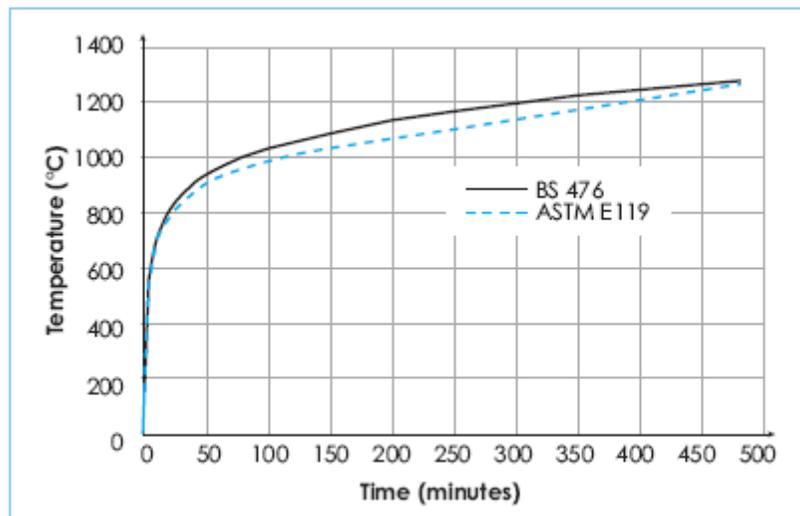
Another term mentioned already is the standard temperature – time curve. It is simply to use and as proven to be very successful with designers and regulators. Please see below for the graph.

But for all the time, effort and research that was put into these methods. There are clear limitations to furnace testing and flaws with the temperature – heat curve.

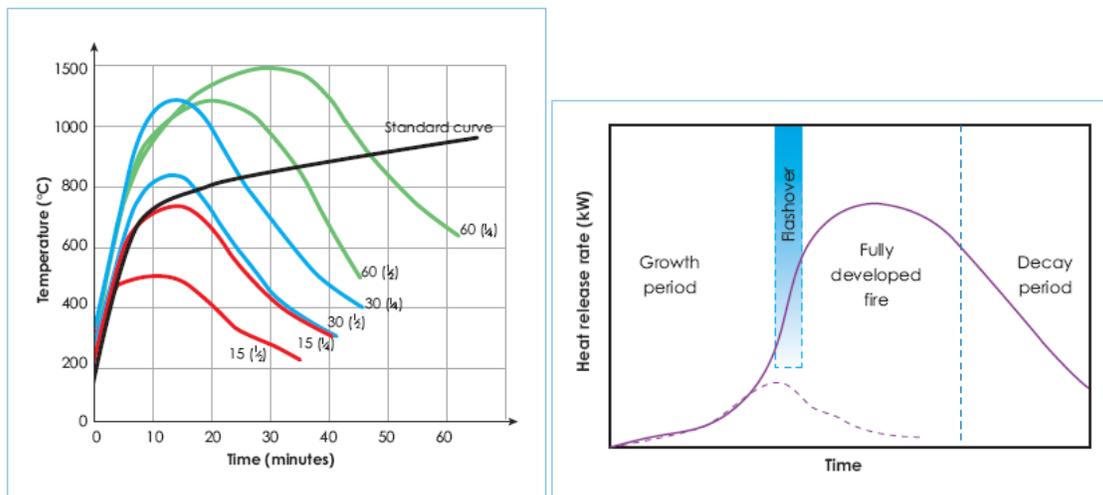
The standard curve is created from typical temperatures taken after flashover and does not represent any decay. These two graphs published by the IstructE shows a number of varied types of fire loads / amounts of ventilation compared to the standard curve. The second shows the stages of a fire.

The differences are clear and show a much higher temperature for a short period (flashover) and the exposure time is reduced (decay).

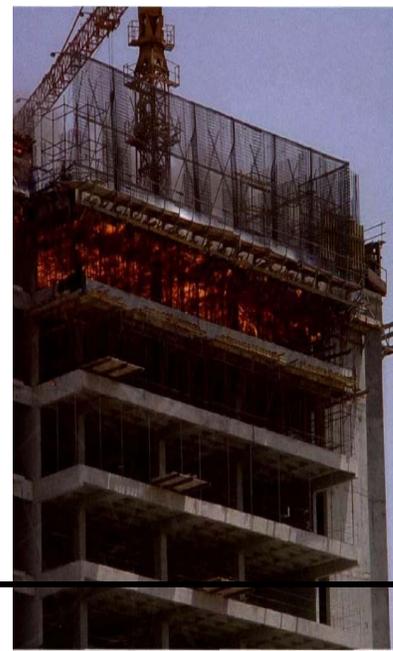
a large fire broke out on a ten-storey reinforced concrete frame building, which occurred during construction. The fire swept through the three upper storeys while the soffit formwork for the slabs was still in place. Although the damage was widespread, it was confined to the outer 20-30 mm of the

underside of the slab and some columns. Tests on samples of the reinforcement showed that the steel had not been significantly affected and hence, the slabs could be economically repaired. The damaged concrete was removed by hydro-demolition or manually, and was reinstated using sprayed concrete.

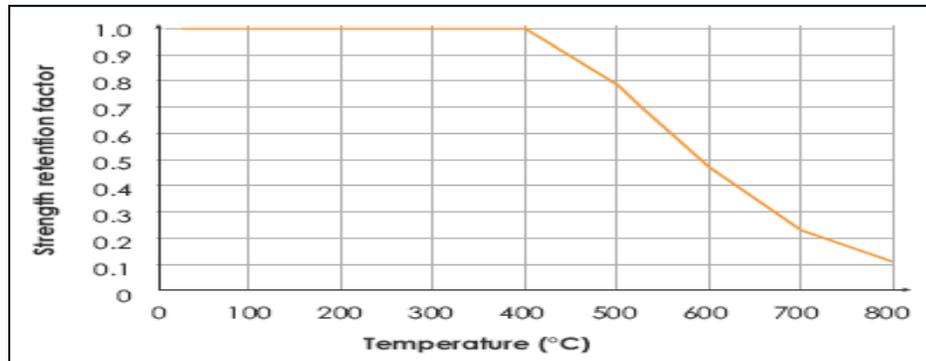
Similar to concrete, structural steel undergoes changes at different temperatures, which drastically affect its structural characteristics. These fundamental stages are as follows, when steel heated it expands at a constant rate, however its strength is not really affected until it reaches 300°C and after this point its yield strength begins to rapidly reduce, when the steel reaches 500°C, known as its critical temperature, its strength has halved. When steel reaches 700-800°C its yield strength is about 10% of its original strength and the steel undergoes a chemical transformation and begins to shrink, this process can be seen in figs. 2.1 and 2.2. However, although the steel structures strength is dramatically reduced during the event of a fire, after it will regain up to 90% of its original strength once the structure has cooled down, therefore requiring minimal amounts of remedial actions

Fig 2.1- strength of steel in relation to temperature

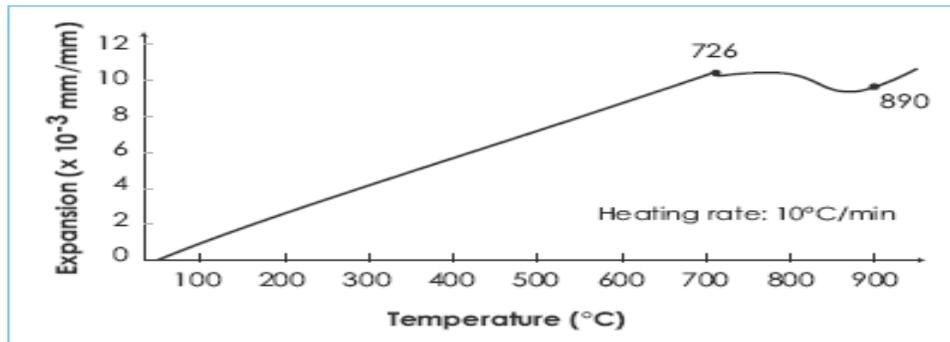
Fig. 2.2- expansion characteristics of steel in relation to temperature

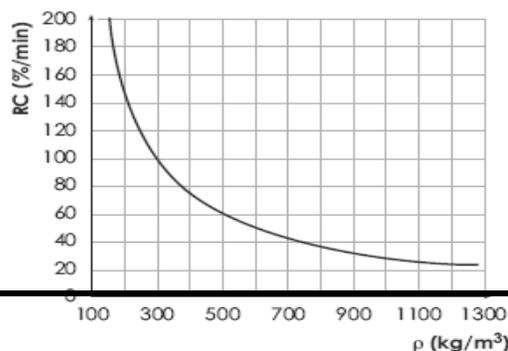
With regards to section size, the rate and ease of combustion is dependant on the surface area to volume ratio, which is why wood shavings will burn readily and large timber sections will not support fire growth unless an additional heat source is present. Therefore large structural members can perform well in the case of a fire. In relation to the density of timber, this is the main factor which determines the time period for the wood to ignite and the extent of fire spread. In basic terms, the more dense the timber is, the greater its fire resistance,

which is expressed in fig.

Fig. 3.1 - showing the relationship between density and the rate of combustion

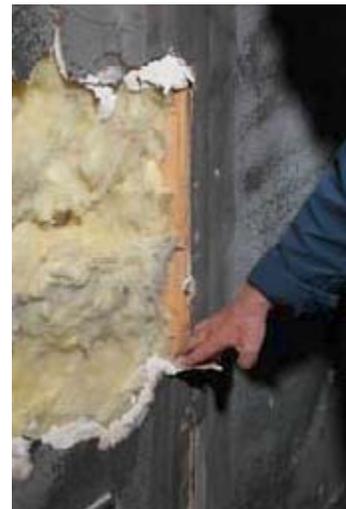
Case study- Sorting House, Manchester 2000, A fire broke out in this four storey timber framed building containing luxury apartments. The fire started on the top floor in one of the apartments, where it was contained. The fire was fairly serious, consuming all the furnishings with in the room and blowing out the windows. Luckily the fire brigade managed to extinguish the fire before it spread to the other apartments within the building. Upon carrying out an assessment of the fire damage to the property, the main structural elements were completely unaffected by the fire and the only damage that had occurred was aesthetic.

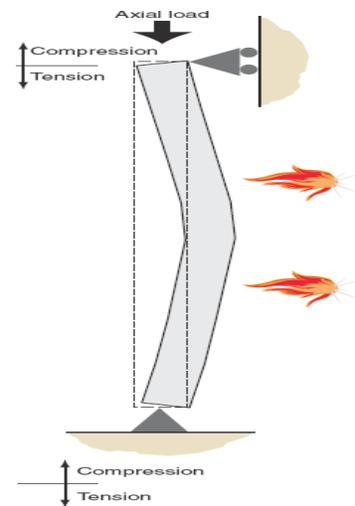
The behaviour of masonry walls and the effect of fire are affected by temperature distribution and the thermal stresses in the wall. This is because masonry walls are predominantly subject to heating on one face, (for internal fires) creating a thermal gradient through the thickness of the wall. This temperature distribution through the wall induces thermal stresses, causing the wall to lean inwards towards the fire. This deflection in the wall results in further stresses due to eccentric loading and if not sufficiently restrained may result in failure. Another problem with regards to the effect of fire on masonry structures is the fact that walls are only constructed of masonry and relies on other structural elements to form the floors and roof. Therefore even though the fire has little impact on the masonry, if the roof members are constructed of timber or steel, then this individual failure can cause the entire structure to fail.
