**Bridge Site - Hydraulic Study**  
**At**  
**Sulaymaniya Governorate**

Prepared by  
**Qadir S. Qadir**

Nov., 2007

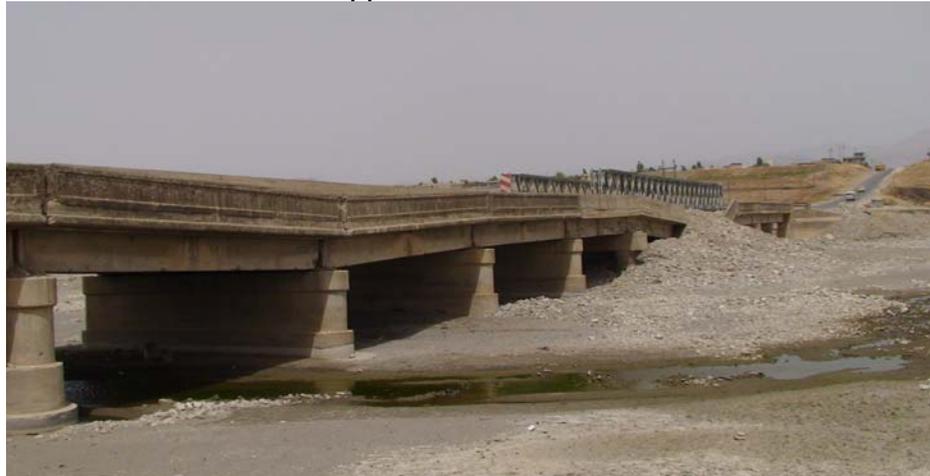
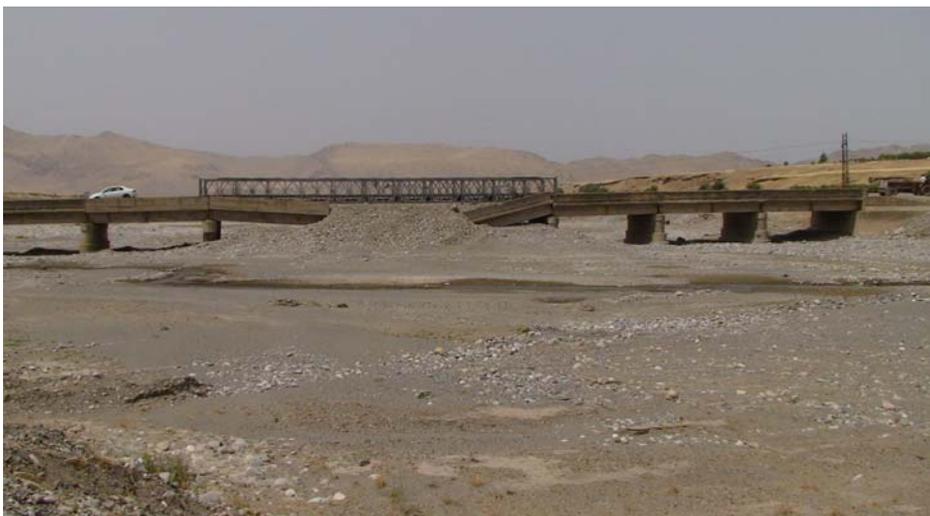
The bridge located over the Zharawa river .The 10.25 m concrete girder structure built in 1961 has 12 spans in addition 10 x 3m box culverts with an overall length of 175 m. Also there are two box culverts at Zharawa side approach.

Zharawa damaged bridge

Late last year, the Zharawa Bridge was greatly damaged by flood. The bridge was subjected to foundation settlement, movement and displacement which resulted in cracks and concrete failure to several beams. In order to keep the road open and to reach other disaster areas, a temporary iron bridge was installed and riprap backfill was placed allowing traffic to cross the Zharawa River.

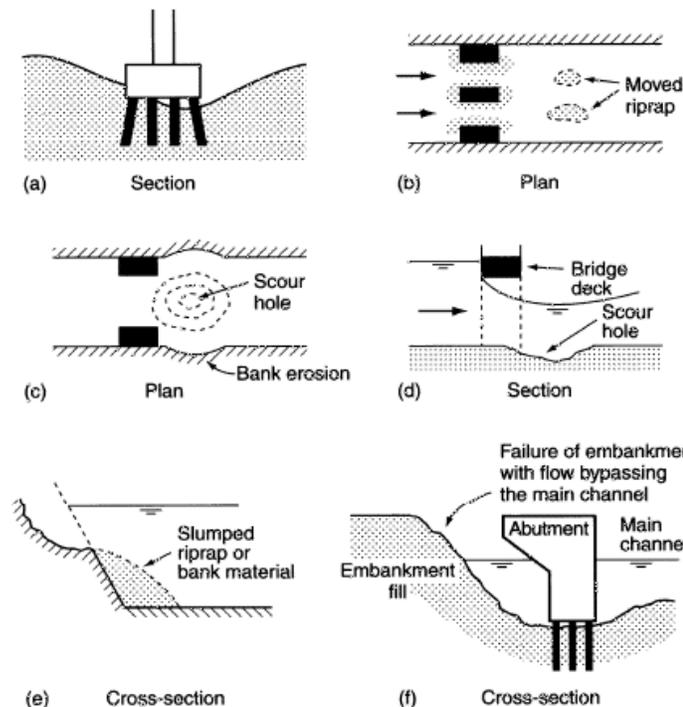
Fig. 1 Some observable effects of scour: (a) pier piles and pile cap exposed; (b) pier and abutment riprap moved downstream; (c) downstream scour hole and bank erosion; (d) downstream scour hole arising from submergence of the opening (pressure flow); (e) slumped material at the toe arising from failure of the riprap or bank; (f) erosion (mass wasting) and failure of the highway embankment with flow on both sides of the abutment.

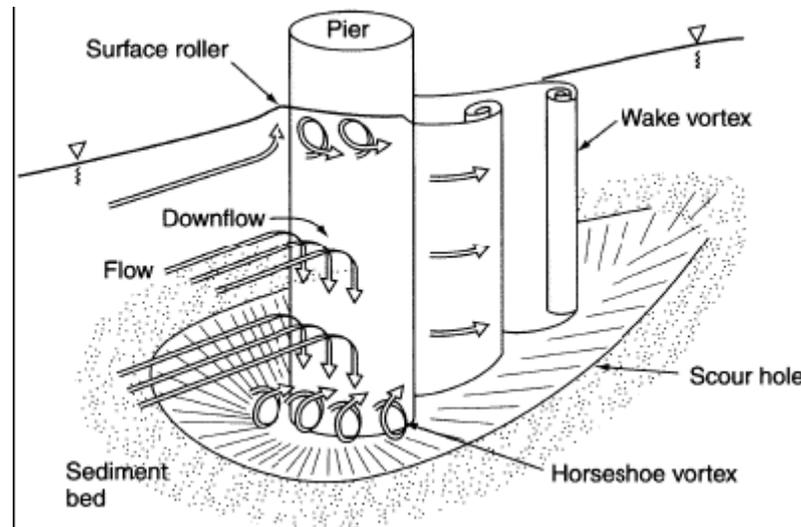
The flow pattern around a cylindrical pier is shown in Fig. 2 the approaching flow decelerates as it nears the cylinder, coming to rest at the centre of the pier. The resulting stagnation pressure is highest near the water surface where the approach velocity is greatest, and smaller lowers down. The downward pressure gradient at the pier face directs the flow downwards. Local pier scour begins when the down flow velocity near the stagnation point is strong enough to overcome the resistance to motion of the bed particles.

Without a scour hole the maximum downward velocity is about 40% of the mean approach velocity ( $V$ ), the maximum strength of the down-flow being recorded just below bed level. When scour occurs the maximum down-flow velocity is about 80% of  $V$  (Copp and

Johnson; Melville). The impact of the down-flow on the bed is the principal factor leading to the creation of a scour hole. As the hole grows the flow dives down and around the pier producing a horseshoe vortex, which carries the scoured bed material downstream.

*Fig. 2 The flow pattern and scour hole at a cylindrical pier. The down-flow, horseshoe vortex and wake vortex are the principal cause of local bed erosion*

The combination of the down-flow with the horseshoe vortex is the dominant scour mechanism. As the scour hole becomes progressively deeper the down-flow near the bottom of the scour hole decreases until at some point in time equilibrium is reached and the depth remains constant.

At the sides of the pier flow separation occurs, resulting in a wake vortex whose whirlpool action sucks up sediment from the bed. As the vortices diminish and velocities reduce, the scoured material is deposited some distance downstream of the pier.

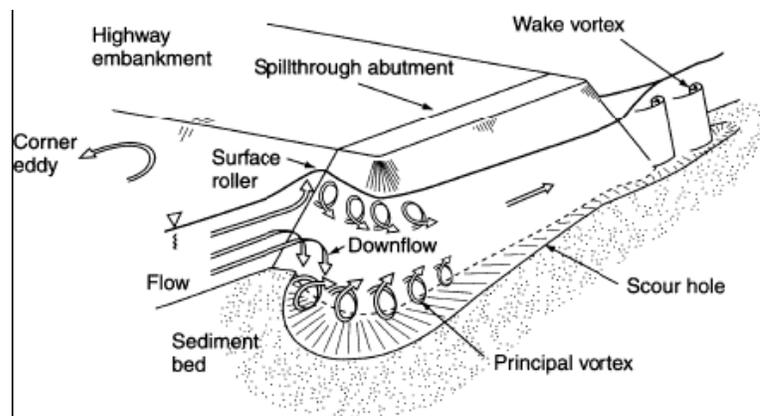
The scour mechanism at a bridge abutment is similar to that at a pier, although the boundary layer at the abutment or channel wall may result in an additional deceleration of the flow compared with a central pier. The approach flow can be considered as separating into an upper layer, which forms an up-flow surface roller on hitting the abutment, and a lower layer, which becomes the bottom or principal vortex (Fig. 3). Viewed in plan, the upper layer divides or separates, with part of the flow accelerating around the upstream corner of the abutment into the bridge waterway while the remainder slowly rotates in an almost stationary pool trapped against the face of the abutment and the river bank. In the bottom layer, the flow near the bank forms an almost vertical down-flow, while that nearer to the end of the abutment accelerates down and into the waterway, forming the principal vortex. Usually scouring starts in this region of accelerating flow and grows along the faces of the abutment. Downstream of the abutment wake vortices form.

Fig. 3 The flow pattern at a spill through abutment. The down-flow and Principal vortex is the main causes of local bed erosion.

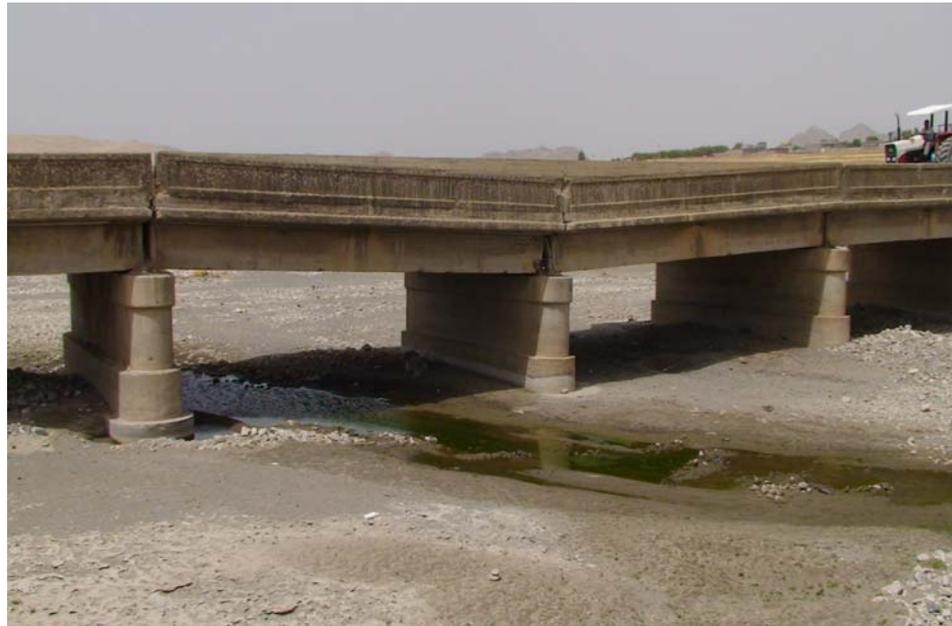
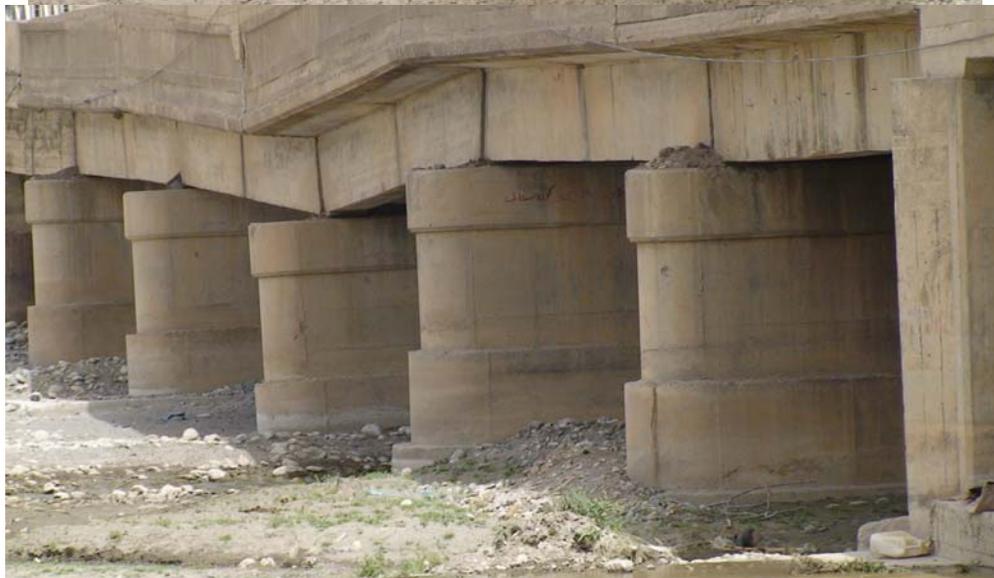
Therefore we know that the reason of this failure is local scouring of the foundation due to the flood.

The above study indicates the critical situation of the existing damaged Zharawa bridge and probability of the major failure is very occur.

Failure of Zharawa bridge (local scour)

The potential for damage to many adjacent private properties due to flooding on the Zharawa river at this site is quite high. The proposed bridge structure must be design to resist and withstand the potential of scour.

The structure must not be skewed and the foundation must be deep to avoid scouring. Also depending on geotechnical study the most suitable foundation used for this bridge is board piles, with deeps range from (10 - 12 m), under the ground surface.

All satisfy there is no chance to use the Zharawa river for navigation and must pitching the bottom of the bridge with stones or rocks to minimize the erosion.
