TAJI MILITARY BASE
SANITARY SEWER NETWORK

Purpose of the study

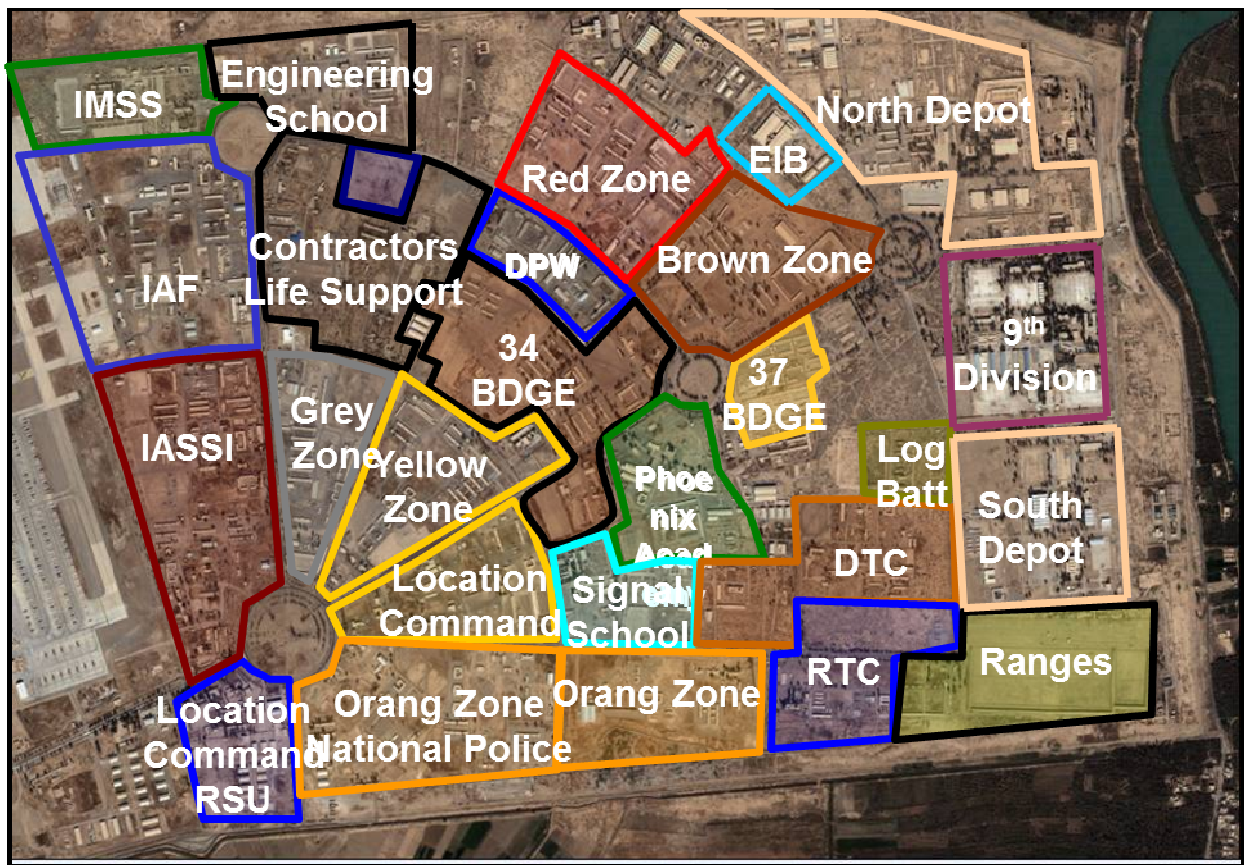
The MOM assessment also led to recommendations for regular sewer cleaning. In response, DPW developed a new cleaning plan that divided the network into 24 areas as shown on the map. Per this plan nine areas will be cleaned each year, with the expectation that the entire system will be cleaned every three years.
